## **Major Clothing Distributor Increases Operating Efficiency, Decreases Maintenance Costs with Flexco Segmented Transfer Plates**

Horizontal to horizontal conveyor

Segmented Transfer Plates

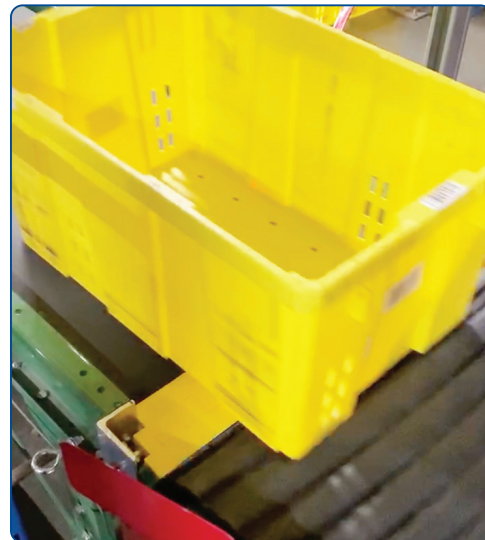
Rubber belt transferring to modular belt

The modular conveyors located at the distribution center of a major clothing retailer transport trays over pop out rollers to a conveyor bed to keep the line moving. Those pop out rollers suffered from premature wear because of the repeated contact with the tray, and they needed to be replaced regularly, costing the facility approximately \$500 in parts and at least 80 hours in labor a year. In some cases, the rollers would fail and pop out, causing product jams at the transfer. This not only slowed the flow of product, but presented a safety hazard if an employee was compelled to stick their hand into the jam to clear it. On top of that, the retailer had to rework the clothes that fell to the ground or sell them at a loss.

The operations manager knew that the problem was costing them time and affecting the quality of their product. So, the next time a Flexco Territory Manager was visiting the warehouse, they offered a solution – Flexco Segmented Transfer Plates. The Segmented Transfer Plates were the perfect solution because they covered the gap and created a tight seal to the belt, preventing product jams and increasing safety by minimizing potential crush points around the transfer.

Upon installing the Segmented Transfer Plates, the need for regular roller maintenance was eliminated and product flow is at peak system efficiency. Because jams at the transfer points were no more, the retailer no longer reports losses due to rework. The operation also saved approximately \$500/year in parts used to replace the rollers and close to \$10,000/year in labor. Safety was significantly improved with a reduction in crush points and pinch hazards at the transfer since the gap is being guarded by the visible yellow segments.
